SECOND FIVE-YEAR REVIEW REPORT FOR  
OESER CO. SUPERFUND SITE  
WHATCOM COUNTY, WASHINGTON

U.S. Environmental Protection Agency  
Region 10  
Seattle, Washington

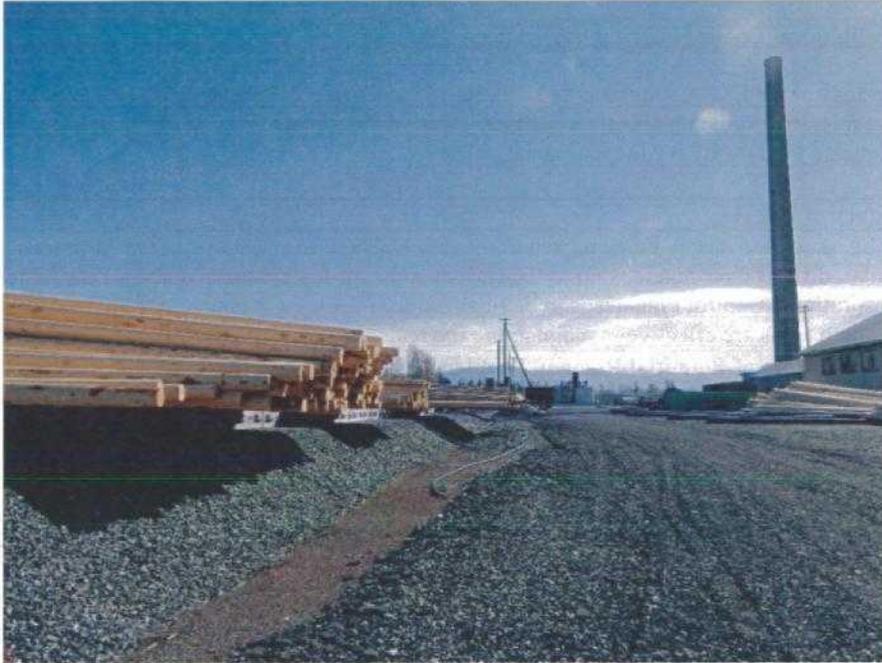
The site inspection included both the Oeser Property and the LSCA. Based on the site inspection, the remedy is performing as expected in both areas. The asphalt and gravel caps were in good condition and drainage on the Oeser property is performing appropriately. The detention ponds were also well maintained and no issues were observed. The LSCA was also in good condition. Vegetation is well established and sampling locations are generally clear and secure. There was some minor indication that homeless people may be using areas with denser vegetation, but no active encampments were observed during the site inspection.

Gravel cap area and southern edge of Cell 1 Repository

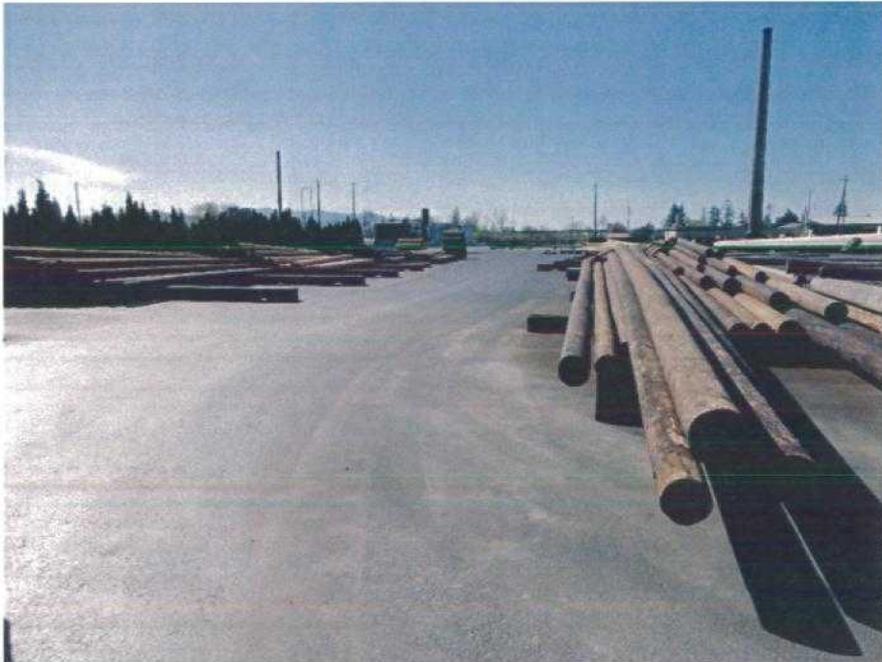
2.	<b>Cracks</b> Lengths: _____ Widths: _____ Remarks: PRP repaired asphalt recently and no cracking was observed.	<input type="checkbox"/> Location shown on site map <input checked="" type="checkbox"/> Cracking not evident Depths: _____

Repaired asphalt in Treated Pole Storage Area

Since the previous FYR, the PRP repaved and resealed the asphalt cap. The PRP also performed maintenance on the ponds, removing and replacing dead vegetation and keeping the ponds free of debris. A granulated activated carbon (GAC) treatment system is maintained to treat stormwater prior to discharge under a National Pollutant Discharge Elimination System (NPDES) Permit administered by the State of Washington. The NPDES permit has effluent limitations for oil and grease, PCP and pH. During the 2011 1<sup>st</sup> FYR site visit, ponded water was observed in the eastern portion of the Treated Pole Storage Area (adjacent to the GAC treatment system). The ponded water was located in a low lying area that is part of the asphalt cap design. Since 2012, the Oeser Company has been utilizing a 20,000 gallon tank to collect and store any water that accumulates on the asphalt cap as the result of storm events. This ensures the continued integrity of the asphalt cap in this area.

OU #	Issue	Recommendations	Current Status	Current Implementation Status Description	Completion Date (if applicable)
Oeser Property	In the northern portion of the Treated Pole Storage Area, approximately 100 square feet of cracks in the asphalt surface was observed during the site visit. The crack pattern is not deep and appears to be the result of subsurface subsidence. Portions of the cracked area have been repaired. The asphalt surface should continue to be inspected and repaired as part of regular maintenance.	Ensure that the O&M Plan includes requirements for inspection of the asphalt cap and criteria for replacement of aging materials.	Completed	Final O&M Plan completed and contains cap inspection and maintenance requirements and cap has been repaired.	7/30/2012
Oeser Property	During the site visit, ponded water was observed in the eastern portion of the Treated Pole Storage Area (adjacent to the GAC system). The ponded water is located in a low lying area that is part of the asphalt cap design. This area should be inspected more frequently (minimum twice per year) to verify that there are no adverse impacts from ponded water storage.	Ensure that the O&M Plan includes requirements for this area to be inspected more frequently (minimum twice per year) to verify there are no adverse impacts from ponded water storage.	Completed	The O&M Plan indicates annual inspection of the cap for conditions such as water ponding on the cap surface. Monthly inspections are also conducted of the cap area and general site conditions.	7/30/2012

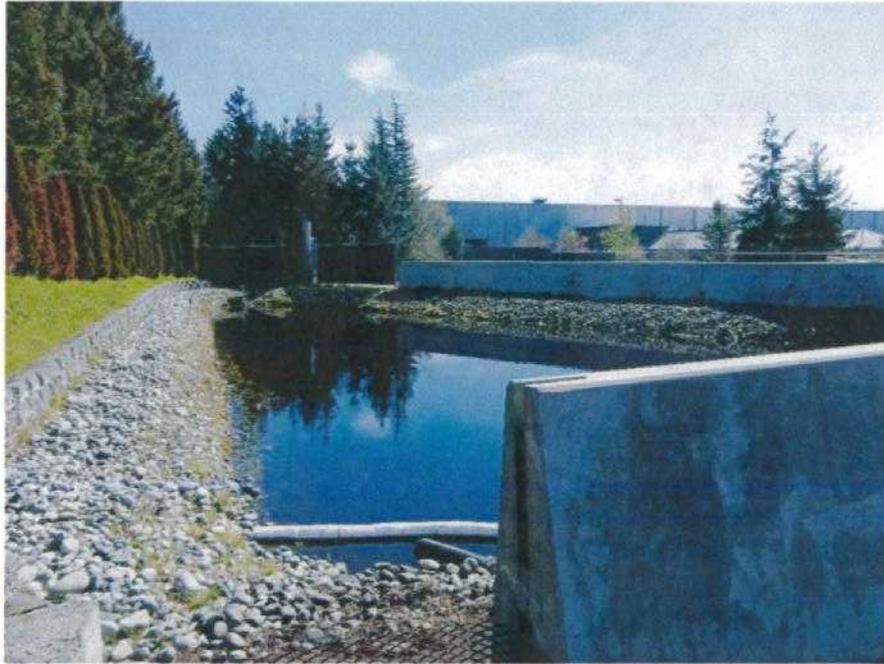
Retention Pond in northeast corner of Oeser Property

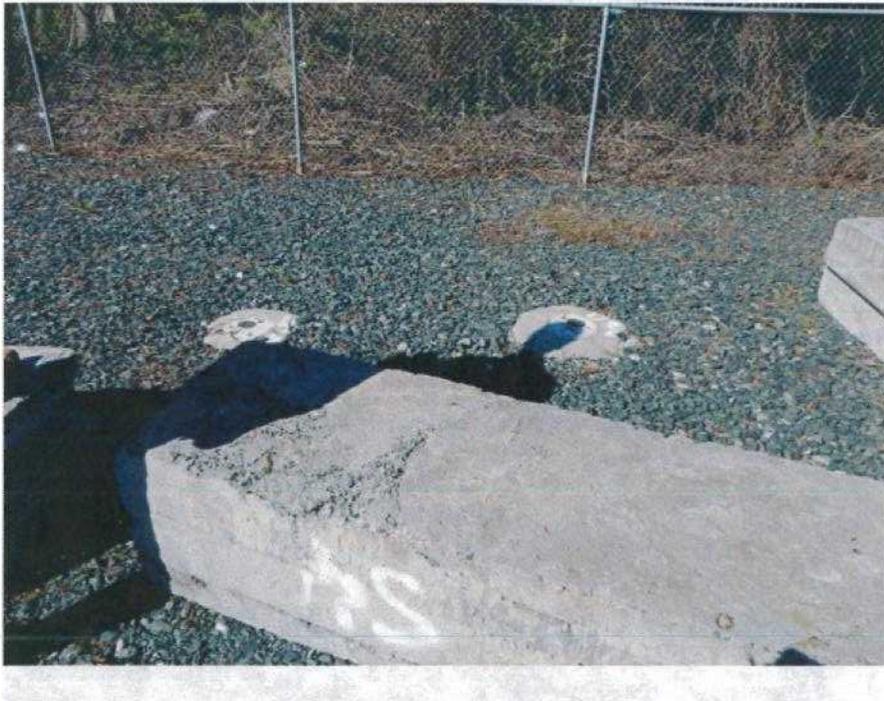
Monitoring wells MW-100D and MW-100S

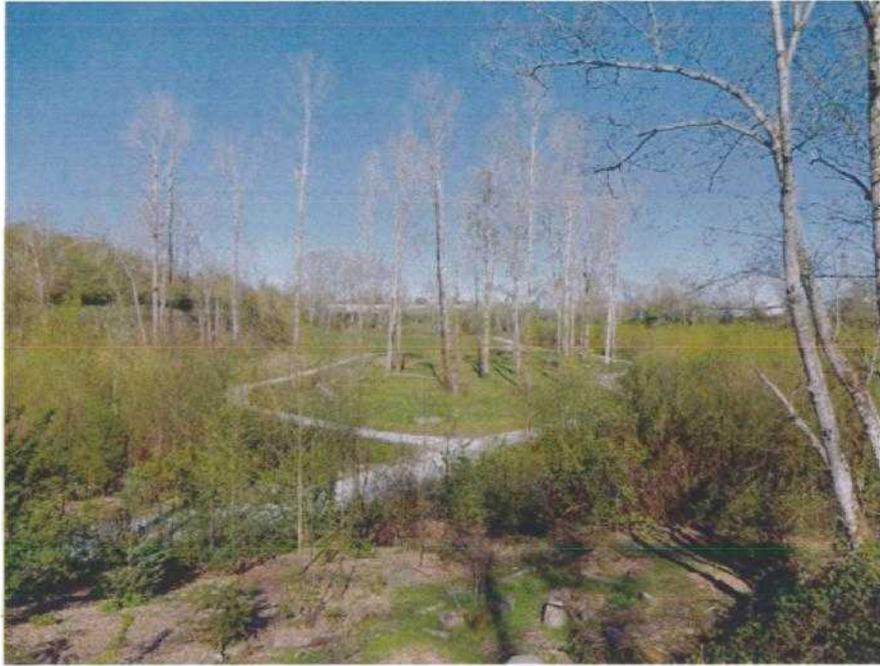
View of upper portion of LSCA Park looking north

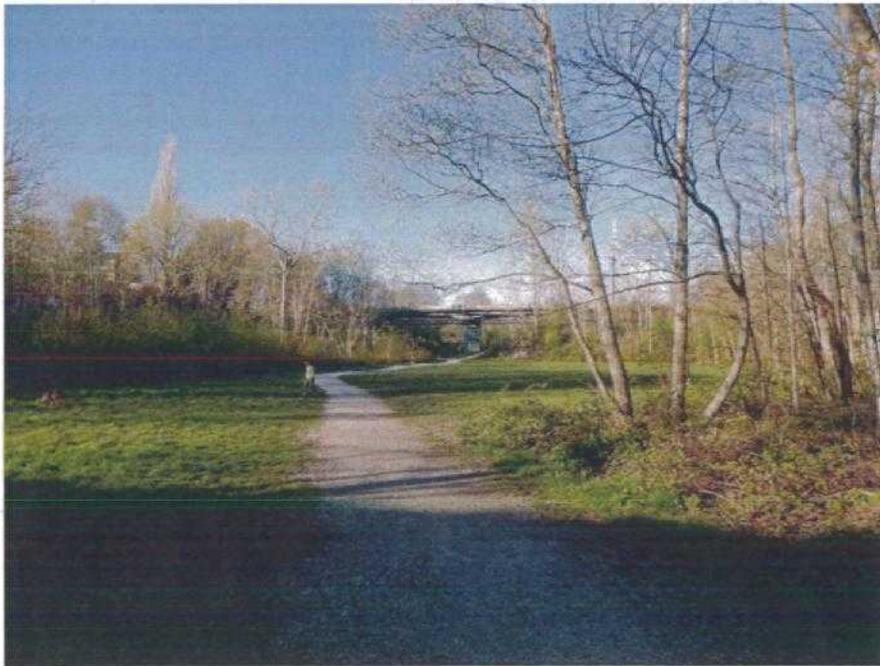
View of lower portion of LSCA Park looking north

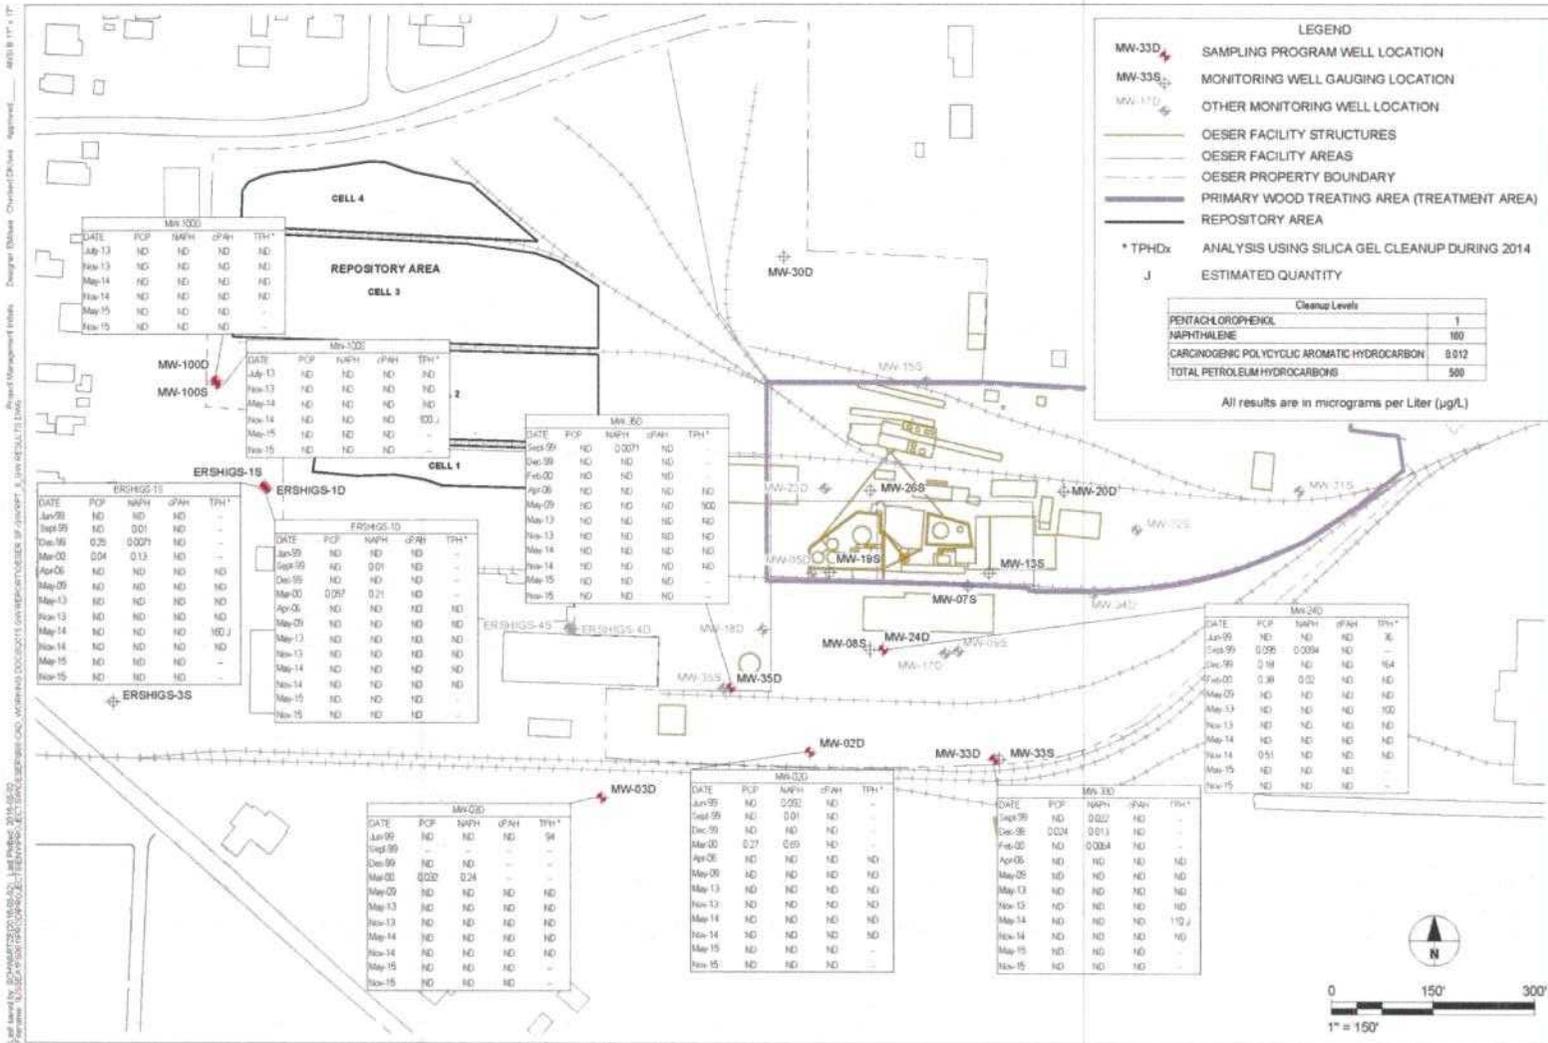
Figure G-1. Oeser Property Groundwater Monitoring Results

The capped areas on the Oeser Property are functioning as designed and the cleanup levels for groundwater are consistently being achieved. Since implementation of the monitoring program in 2013, there have been no exceedances of the cleanup goals; however dioxins and TPH-gasoline range are not being analyzed. These omissions are in accordance with the O&M plan. Dioxins were excluded from the monitoring program due to the background levels of dioxins upgradient of the Site, and the fact that none of the concentrations observed during the RI exceeded their respective screening levels. The COC TPH is defined as applying to both diesel-range and gasoline-range organics in the 2003 ROD; however only diesel range and motor oil are being sampled for during the monitoring events. The removal of these constituents from the Site monitoring plan should be documented in a memorandum to the file.

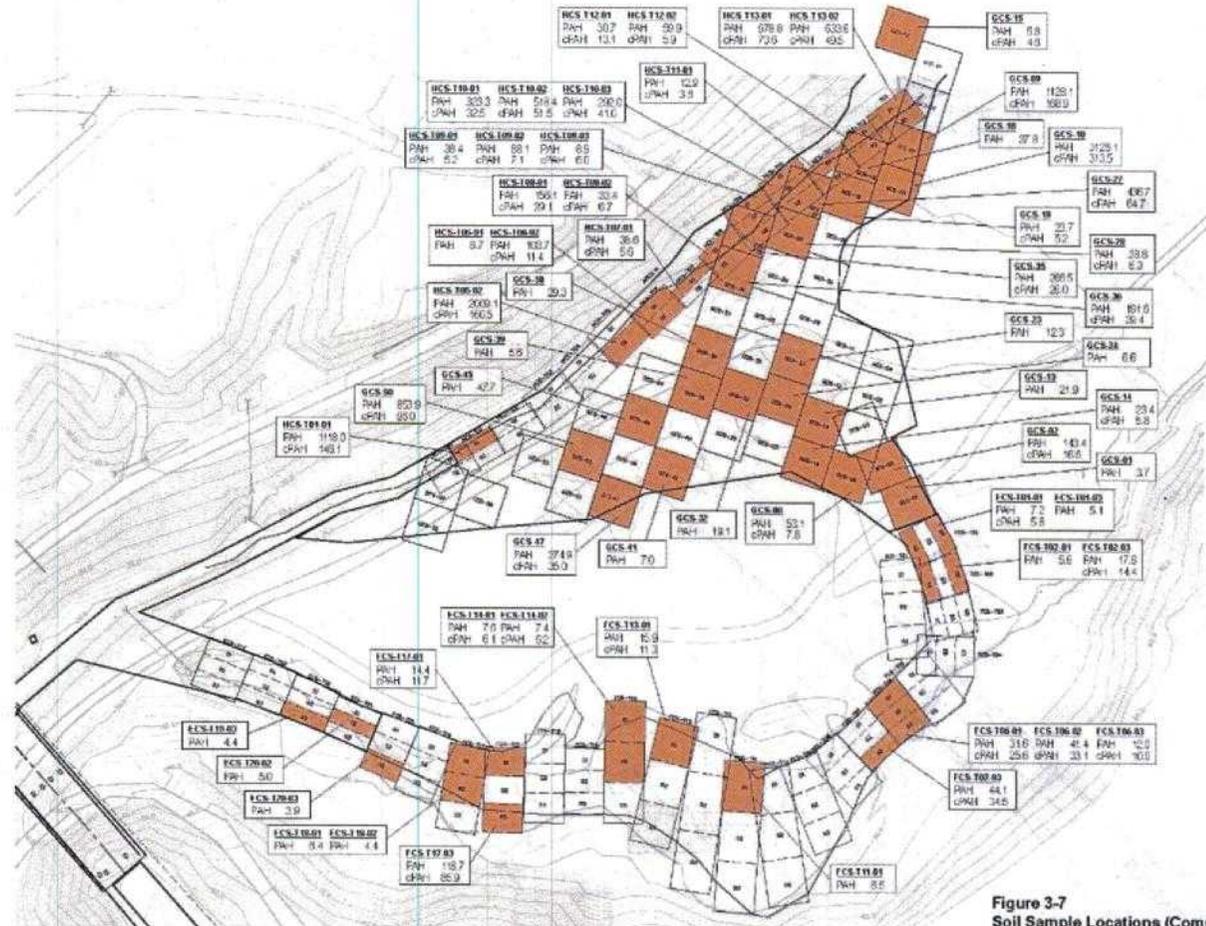
All units in mg/kg

Contaminant concentrations shown are 6 feet below final grade.

Figure 3-7  
 Soil Sample Locations (Composite)  
 for Confirmation After Excavation  
 During Phases 1 and 2 Removal Action  
 Construction Completion Report  
 Oeser Site

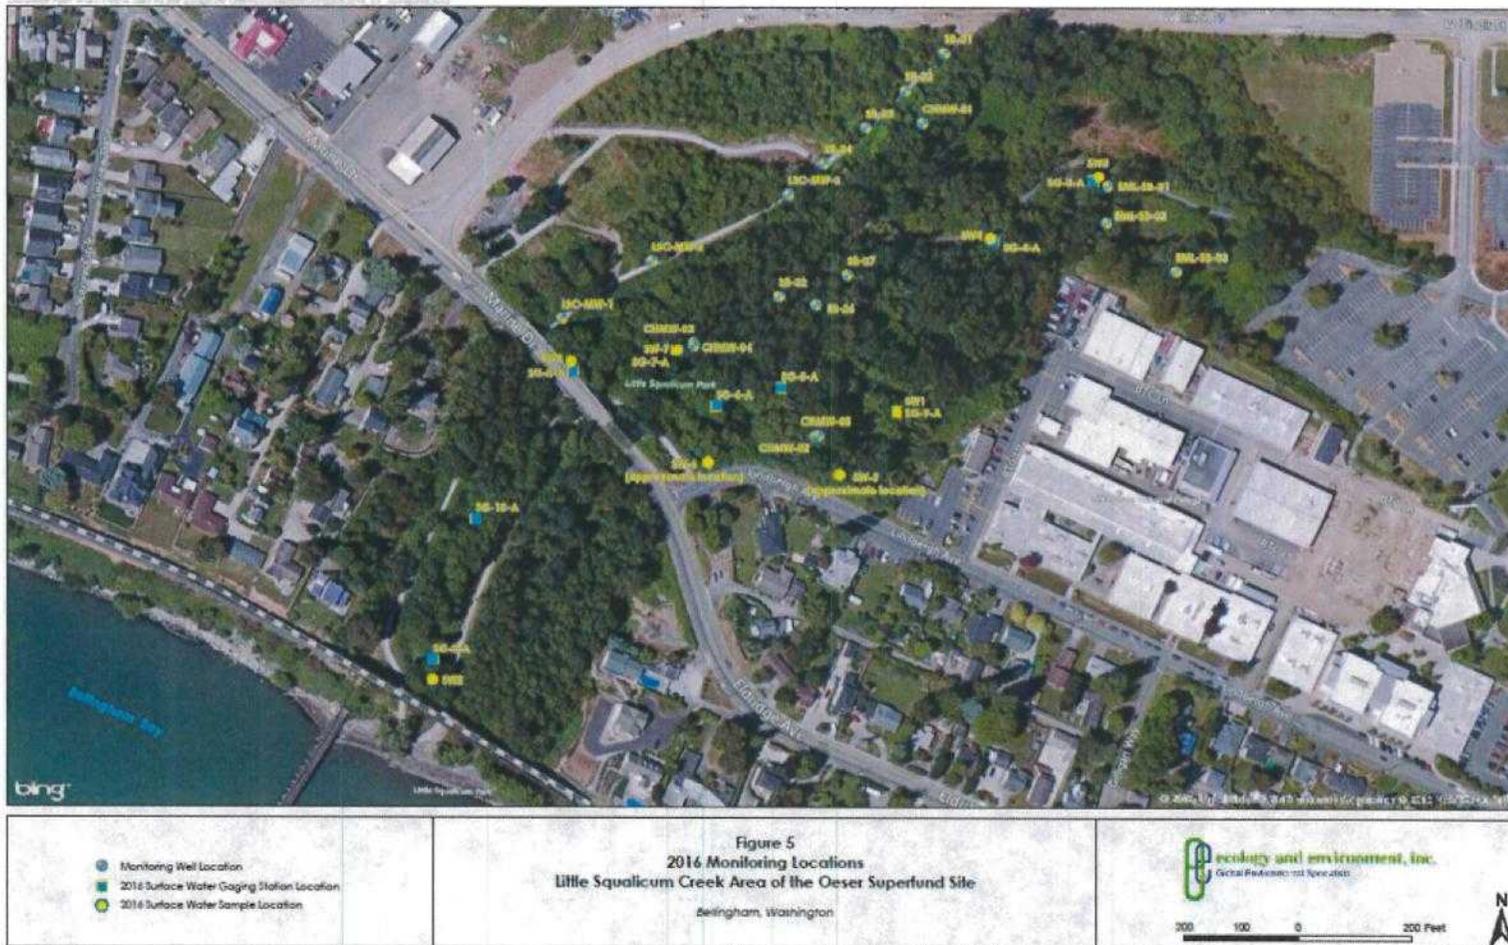
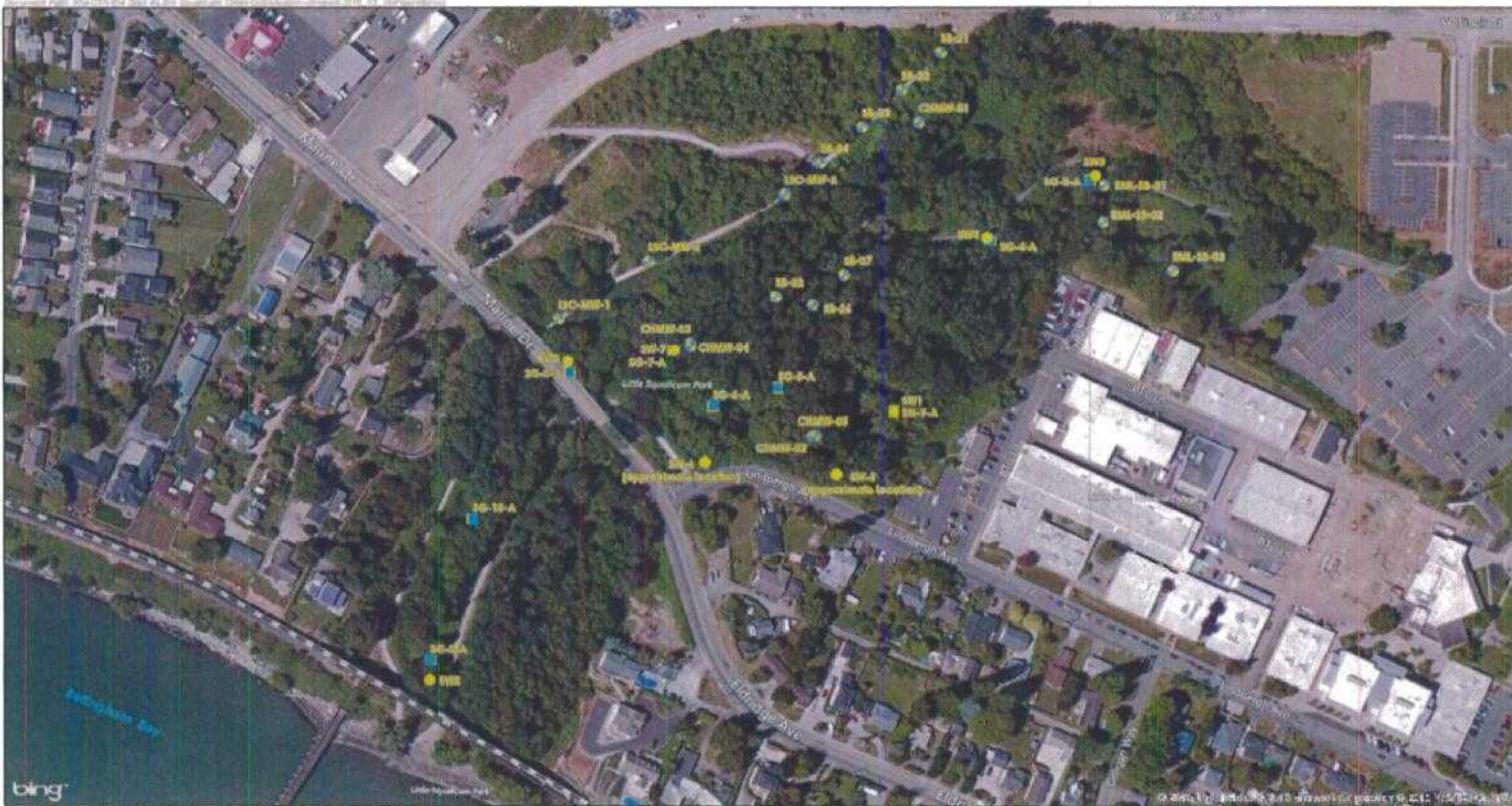
Figure G-4. 2016 Surface Water Sampling Locations

There were no exceedances of the lowest applicable criteria in 2013, 2014 or May 2015 at any location. In November 2015, detections above the lowest screening level were observed in SW-1, although SW-1 is located upstream of the waste left in place, for benzo(b)fluoranthene, chrysene and PCP. The samples from SW-3 or SW-4 were not submitted for analysis.

**Figure 5**  
**2016 Monitoring Locations**  
**Little Squalicum Creek Area of the Oeser Superfund Site**  
 Bellingham, Washington
